## Tank Performance “Under Fire”

*Keys to keep your fire suppression storage systems in-service with long-life, operating safely, and ready to perform when it counts.*

**By David Oveson**

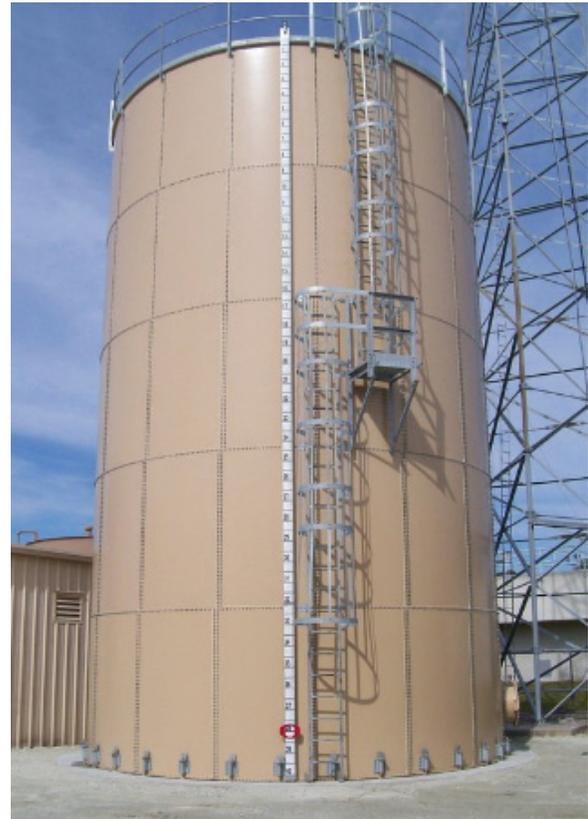
*Protect your Investment: A fire protection tank is a primary asset to a facility, and critical to the success of a fire suppression system. A robust and documented inspection and maintenance program can help assure many years of “at-the-ready” service life.*

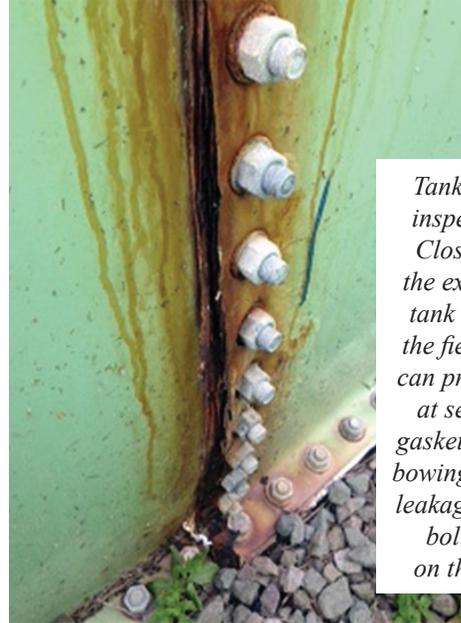
*Tank without proper inspection program: Close inspection on the external parts of a tank that has been in the field for some time can present visible rust at seams, degraded gasket material, visible bowing in steel, signs of leakage, and rusted out bolts (shown here on the bottom ring).*

only,” explains Tom DeDonder, VP of Construction Services of CST. “While the condition of the hardware, gasket, welds, and the integrity of the coating and structural components are of critical importance, there are many items like relief vents, nozzles, anchors, the foundation, insulation, heaters, etc., that are vital for the tank to operate safely. So, it’s imperative to identify issues early-on before they develop into a problem.”
