## Tank Performance “Under Fire”

*Keys to keep your fire suppression storage systems in-service with long-life, operating safely, and ready to perform when it counts.*

**By David Oveson**

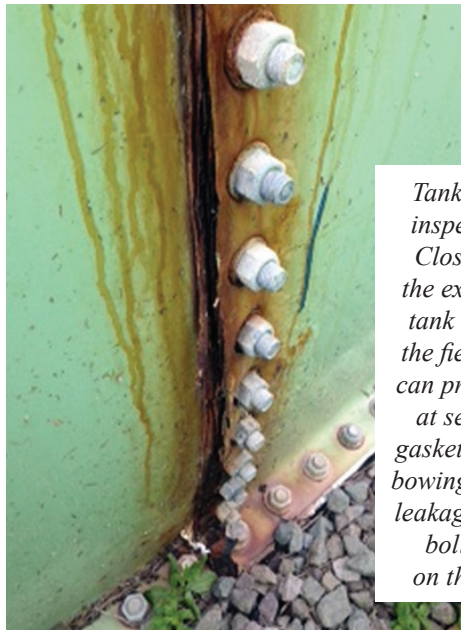
*Tank without proper inspection program: Close inspection on the external parts of a tank that has been in the field for some time can present visible rust at seams, degraded gasket material, visible bowing in steel, signs of leakage, and rusted out bolts (shown here on the bottom ring).*
